4629 N BROADWAY

THE BUILDING

REMAKING

Case Studies In Brick

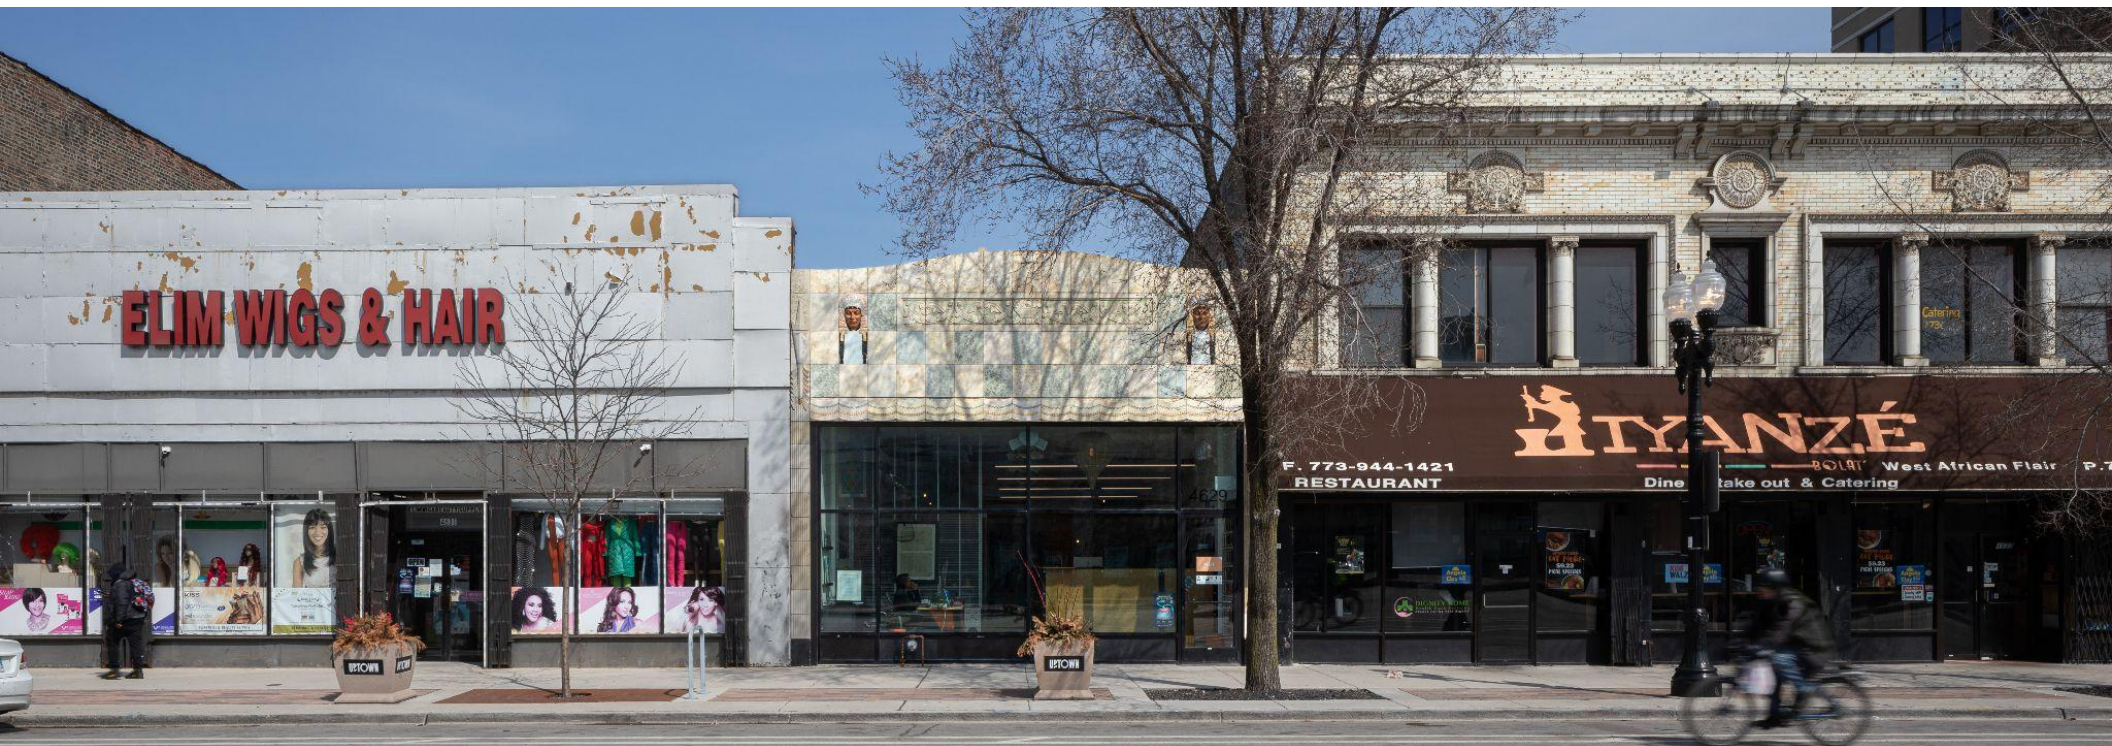
Designed by architect Carl Hauber, 4629 Broadway is a slim one story building with large display windows framed by fluted terra cotta pilasters and blocks with blue and gold garlands. Above the window the mottled terra cotta alternates blocks of blue and white in a checkered pattern with an inset panel of flowers and classical imagery.

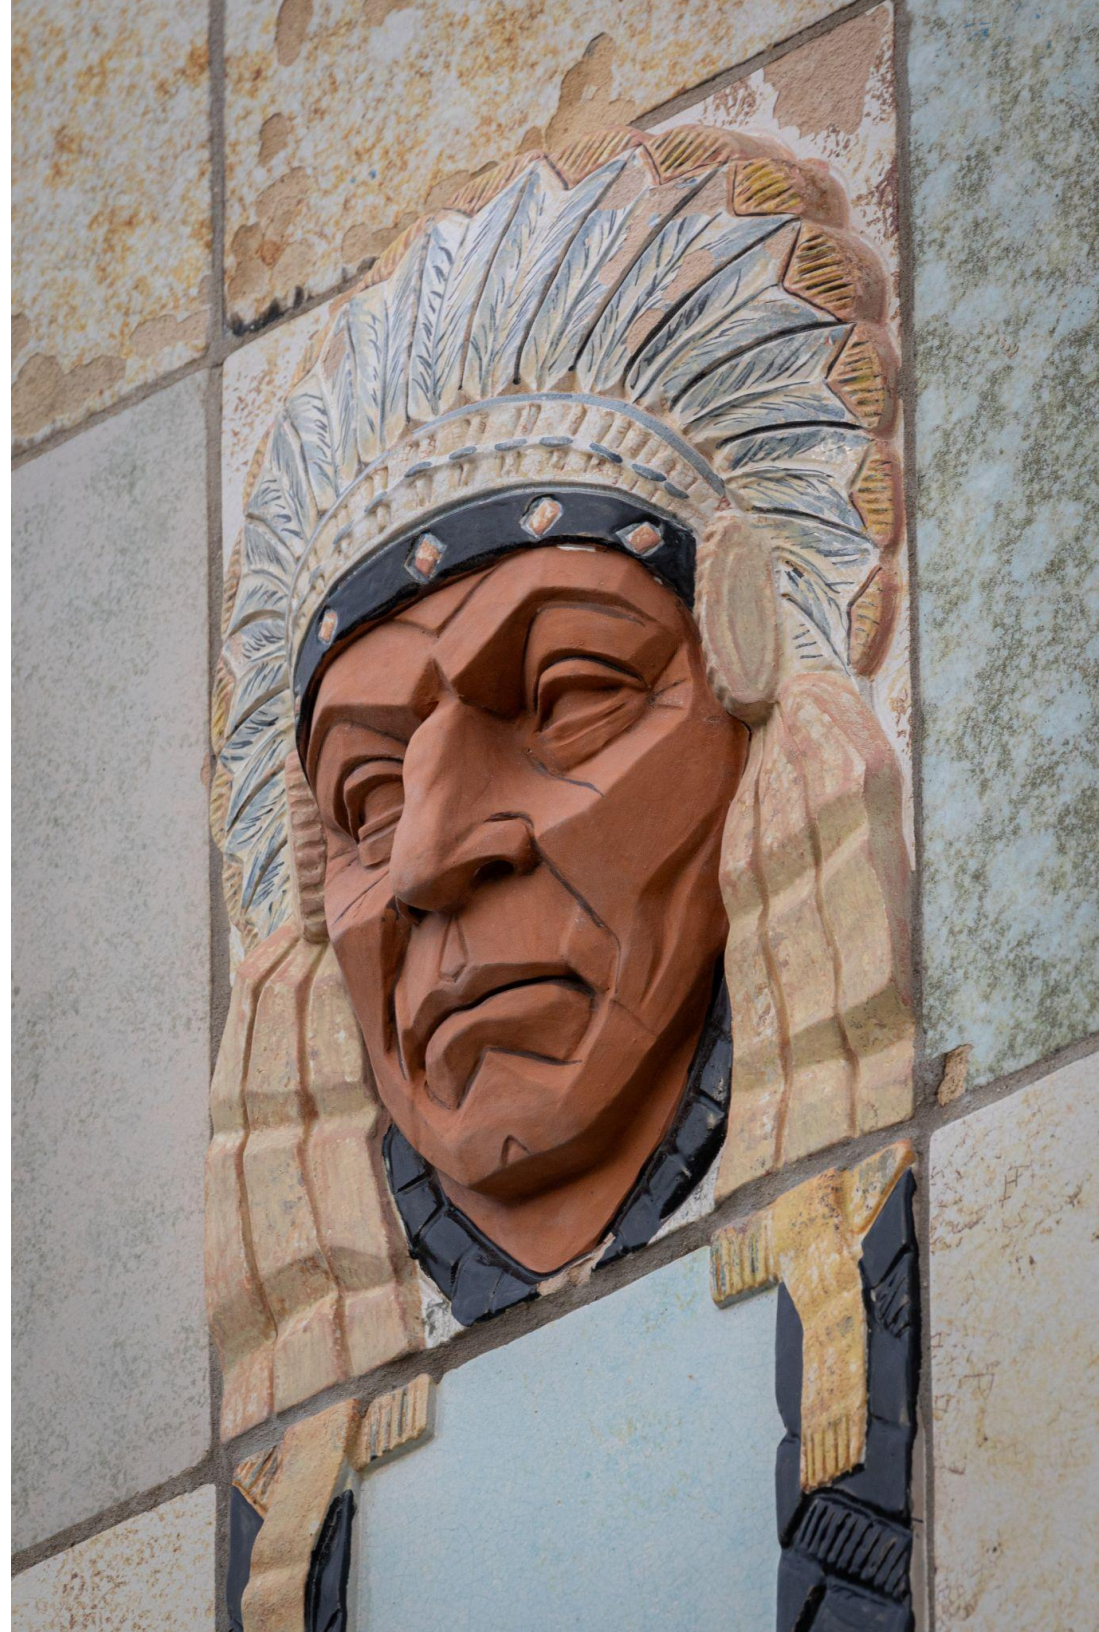
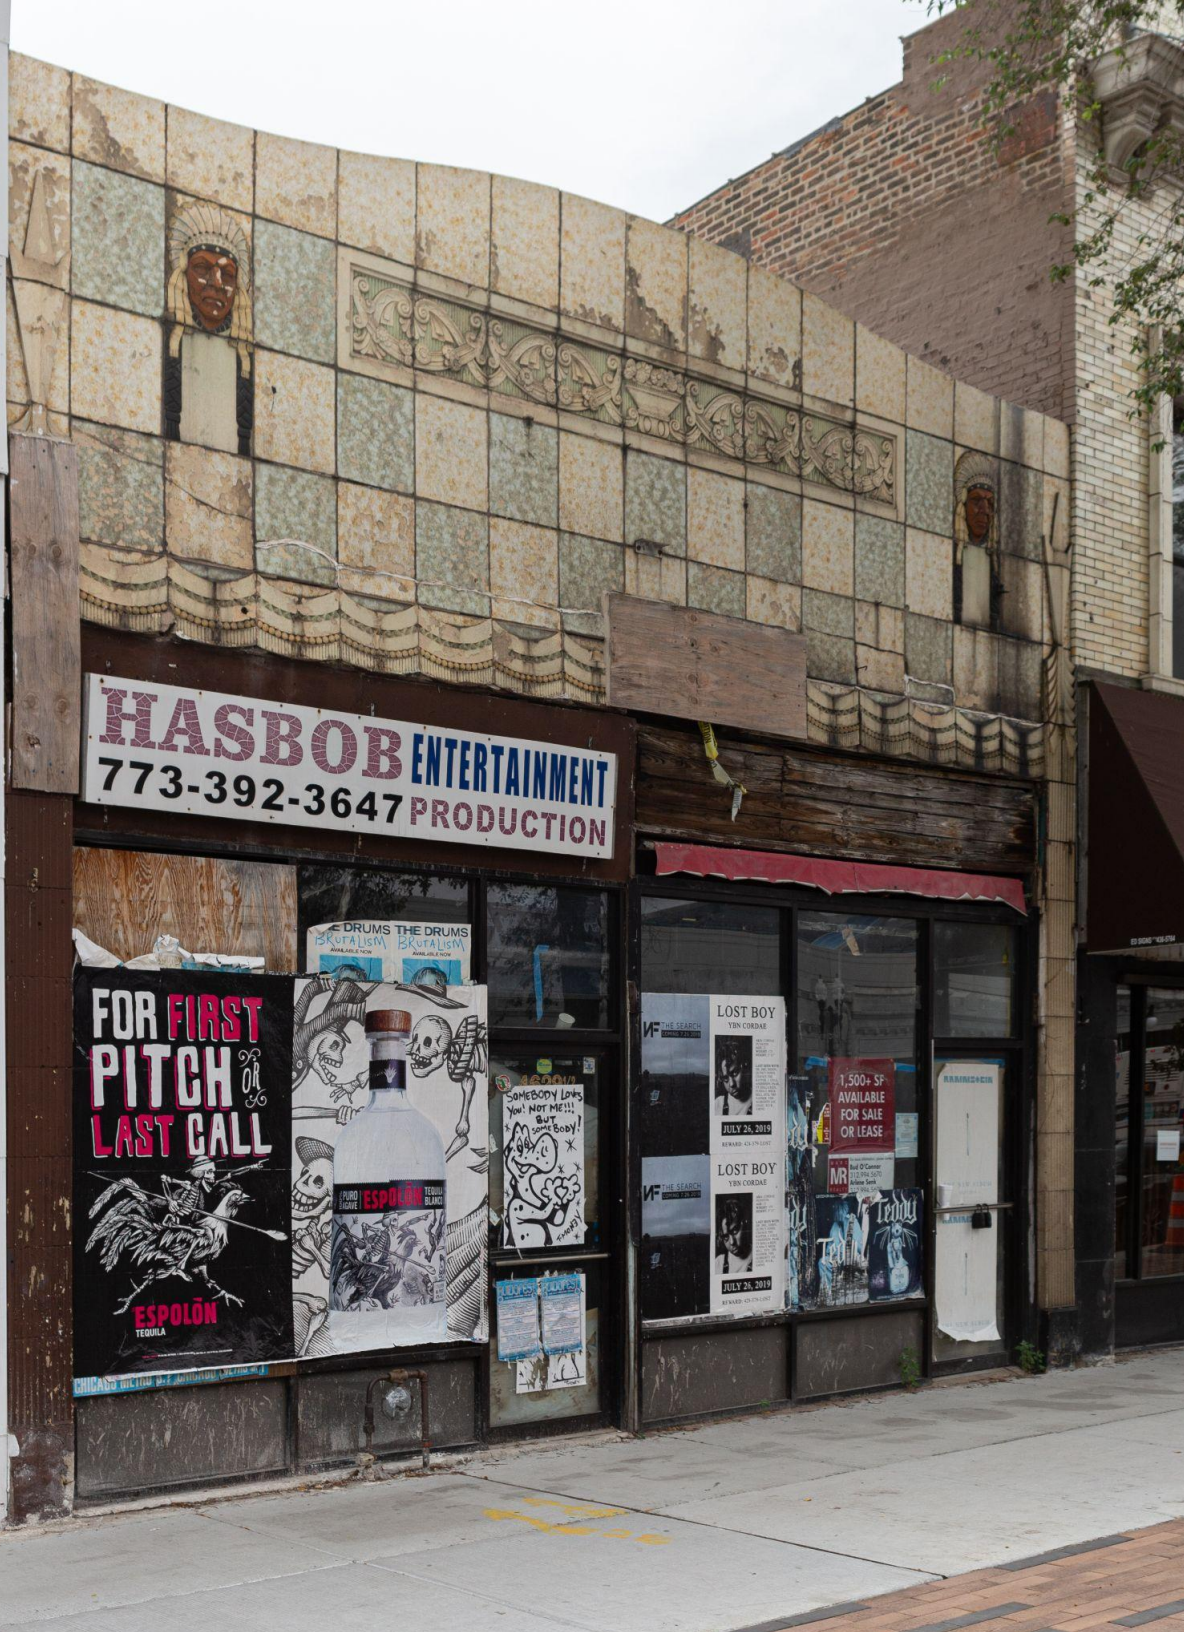
The most striking and unique parts of the terra cotta facade are the two stern and sharply angled men depicted as Native Americans with their headdresses that flank either side of the facade.

The faces have an Art Deco quality in their abstraction that is balanced by a delicate realism in the silvery-blue flowers of the headdress.

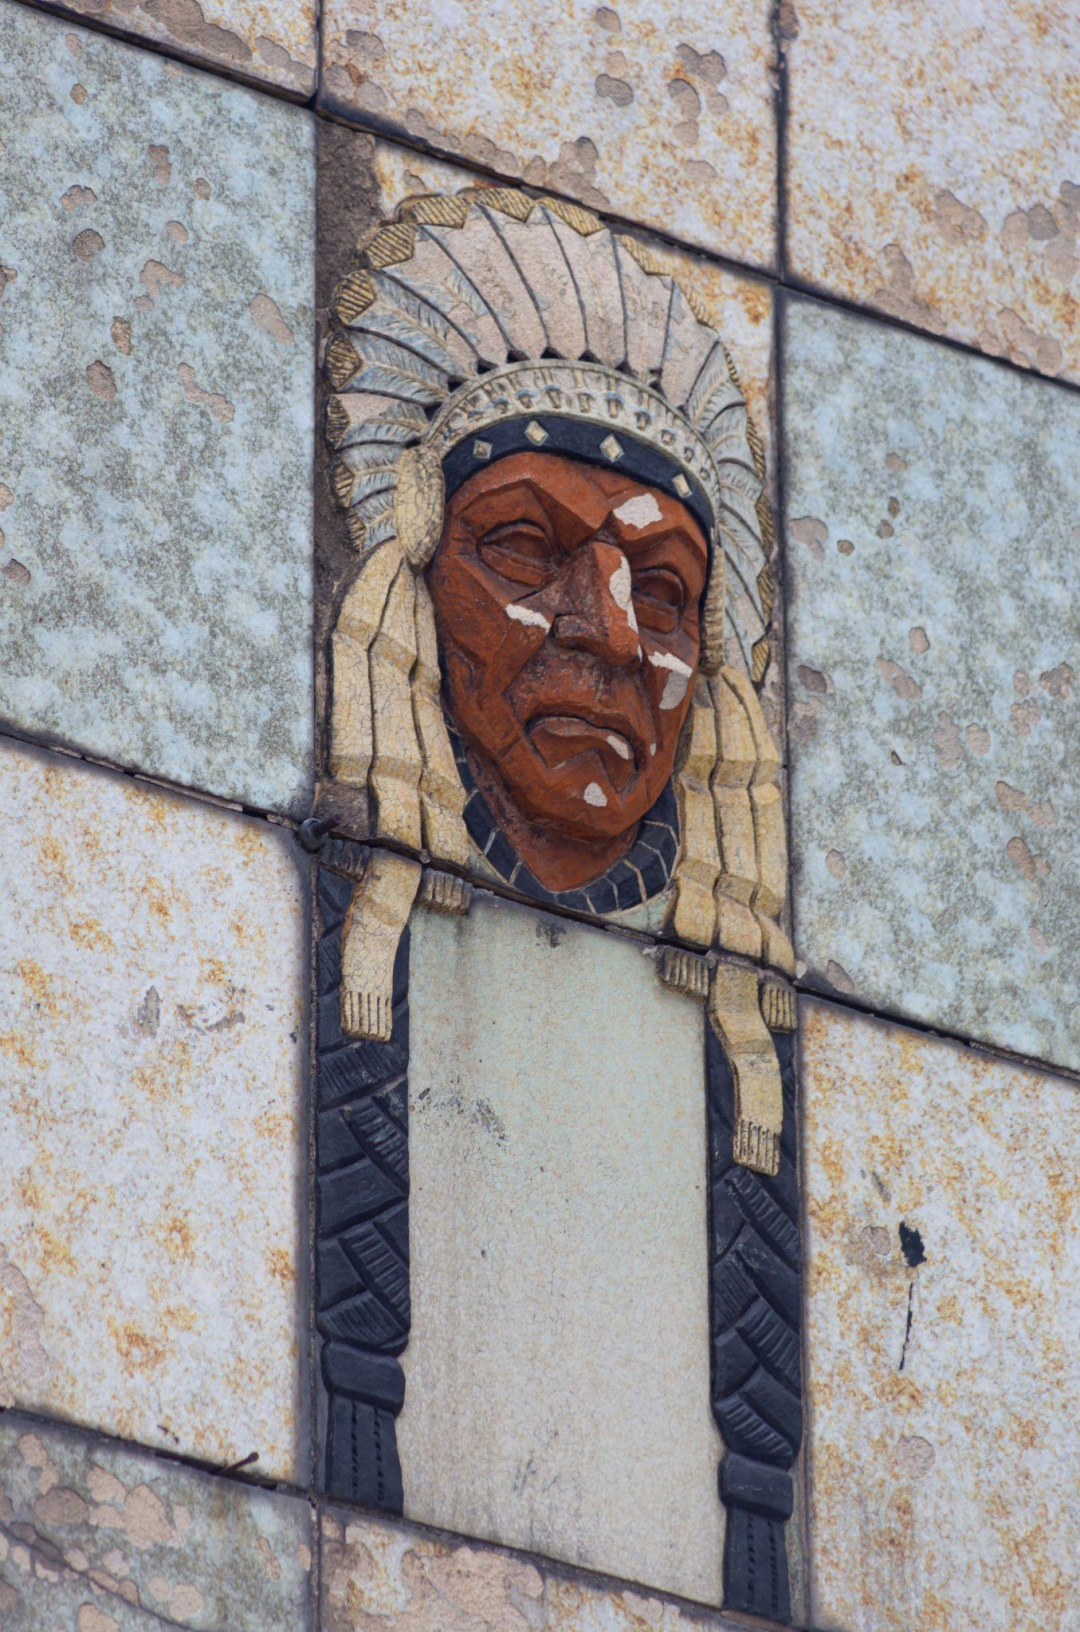
By the early 2000's, 4629 Broadway, had lived many lives and seen many different tenants. Each tenant's needs had been different, causing the facade to be altered or changed little by little over the decades. Paint had been slathered on in layers, signs had been affixed and removed, bolts and hardware had been driven through the terra cotta blocks and in some areas, plywood had even replaced several of the original pieces.

The surviving pieces the terra cotta facade had not fared much better due to a lack of proper maintenance over the years. This wreaked havoc on the now brittle terra cotta facade.

Unfortunately, the faces had not fared any better than the blocks. They were left chipped and broken; hardly recognizable from their state during installation nearly 100 years earlier. The face shown on the right was covered in so much soot and dirt, that all the angular demarcations had nearly been lost. On the left, the face had lost large pieces of the cheek, chin, nose and forehead. On both, feathers on the headdresses had were mostly lost.

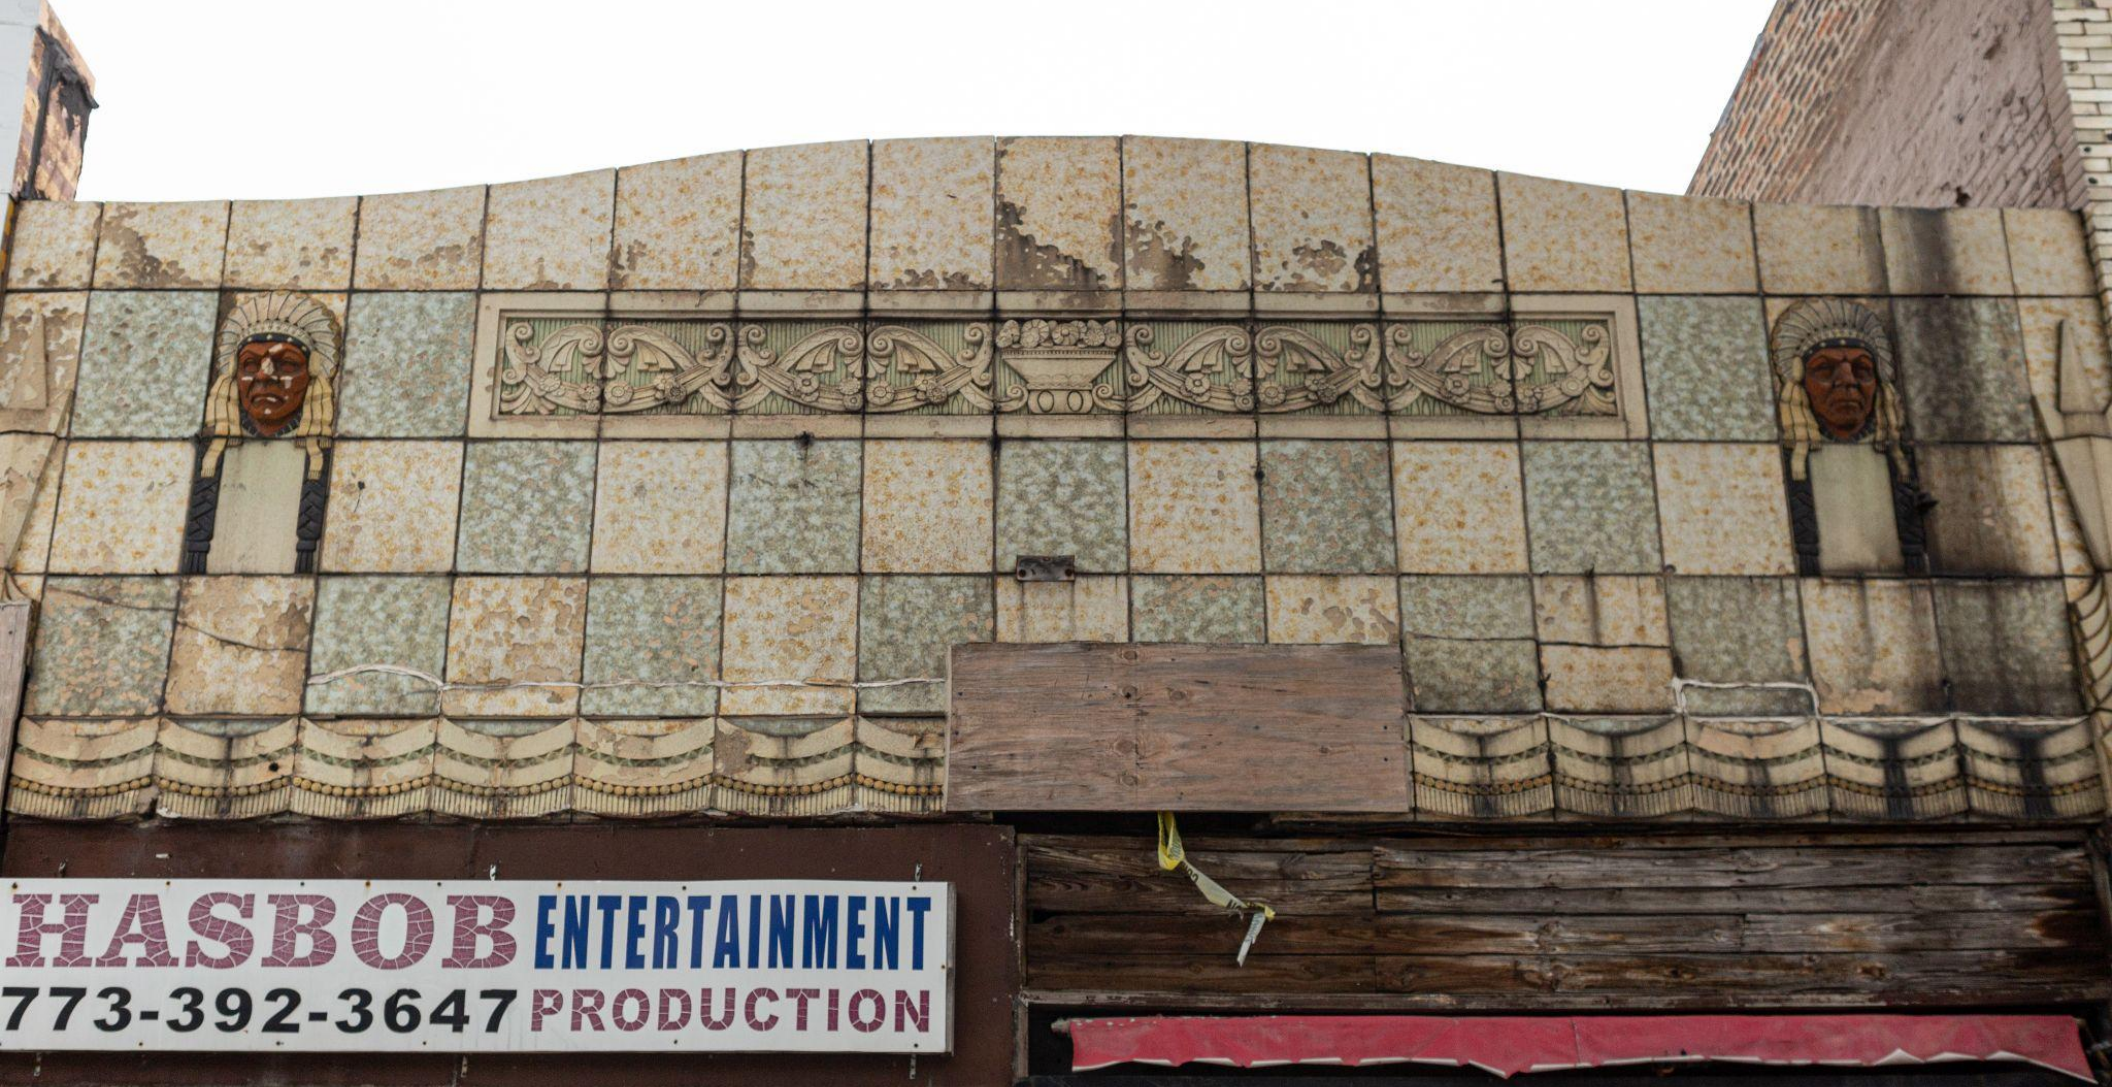
To begin the restoration and reparation process, the first step was to assess the the condition the facade was in.

"It was in dire shape," says Conrad Szajna of Formed Space, the general contractor on the project. "Numerous pieces were cracked and crumbling. We had to pay special attention and take our time removing each individual layer".

It was determined that a full facade restoration would be too complicated and costly, thus it was decided to attempt to maintain as much of the existing materials as possible and only recreate what was necessary.

In order to remove the facade, Formed Space worked slowly and carefully from the top down, row by row and block by block. Just prior to the removal of each piece, it was photographed, tagged and marked on a map of the facade. This detailed inventory process of each piece would facilitate putting it back together again.

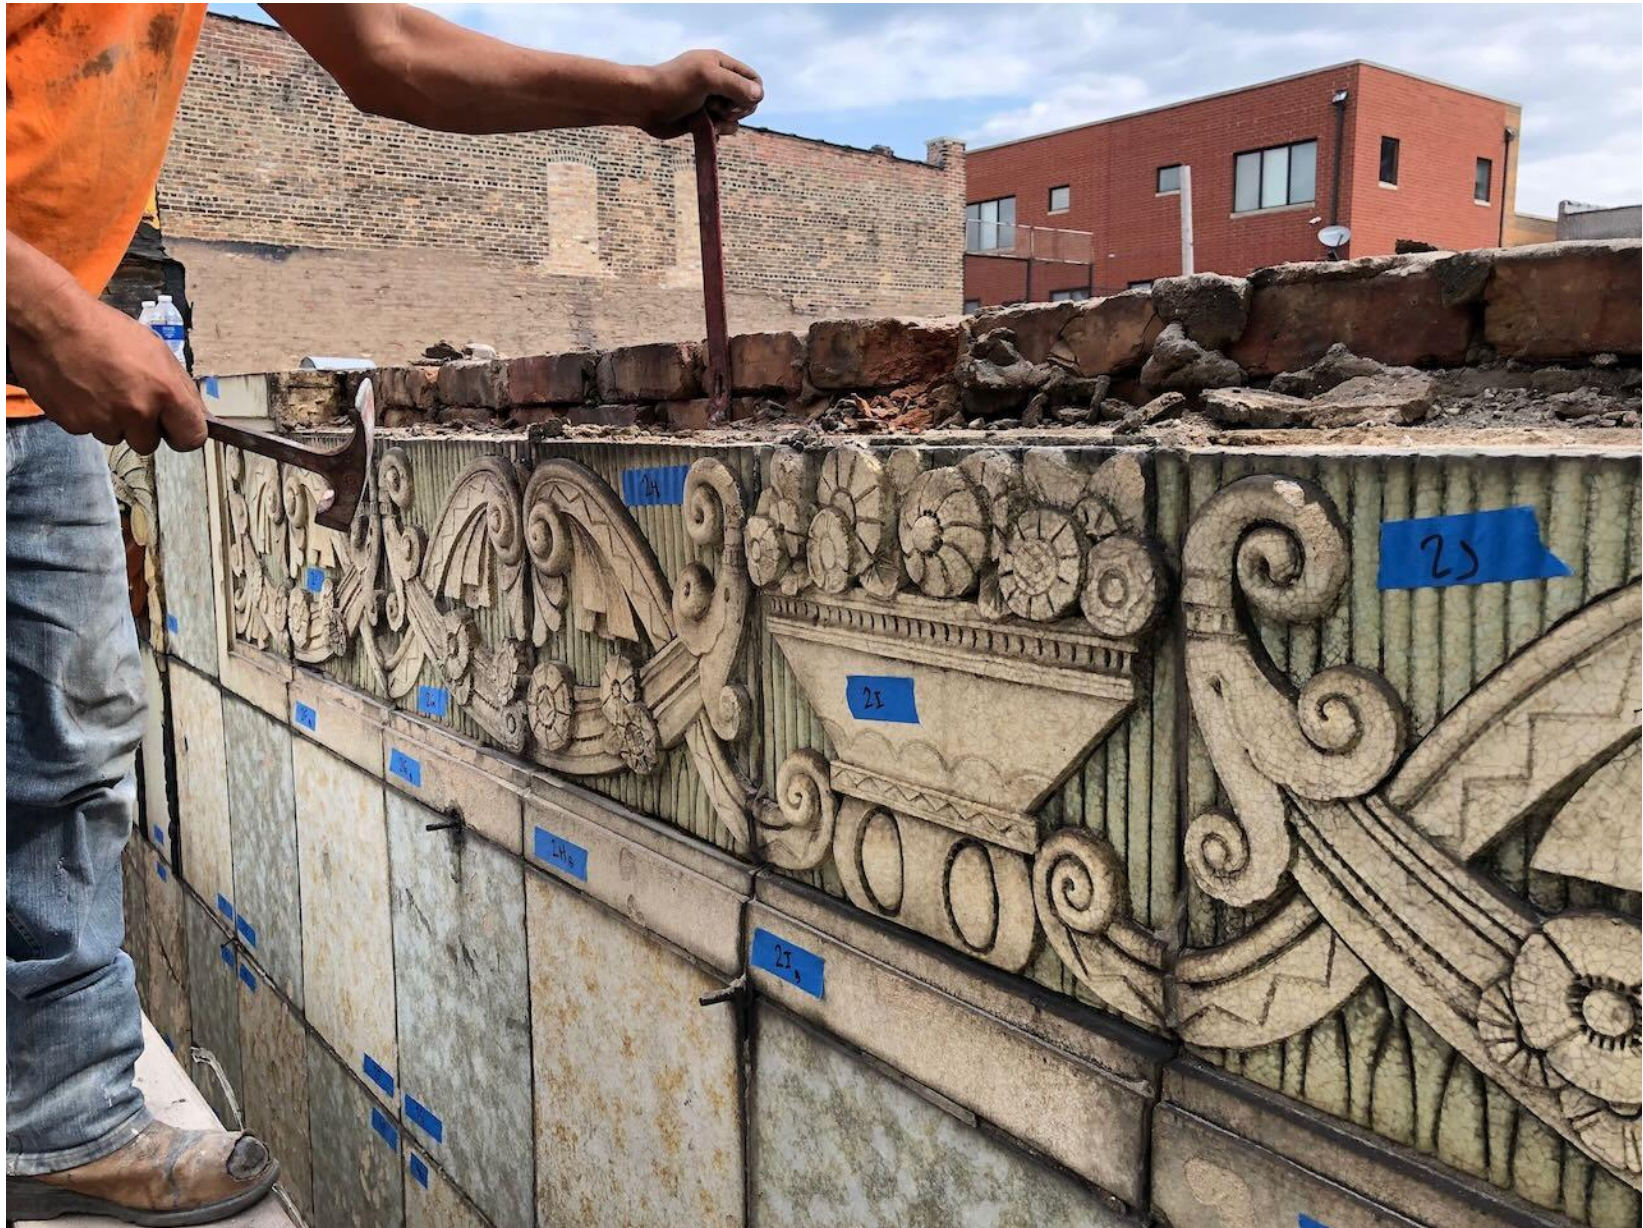
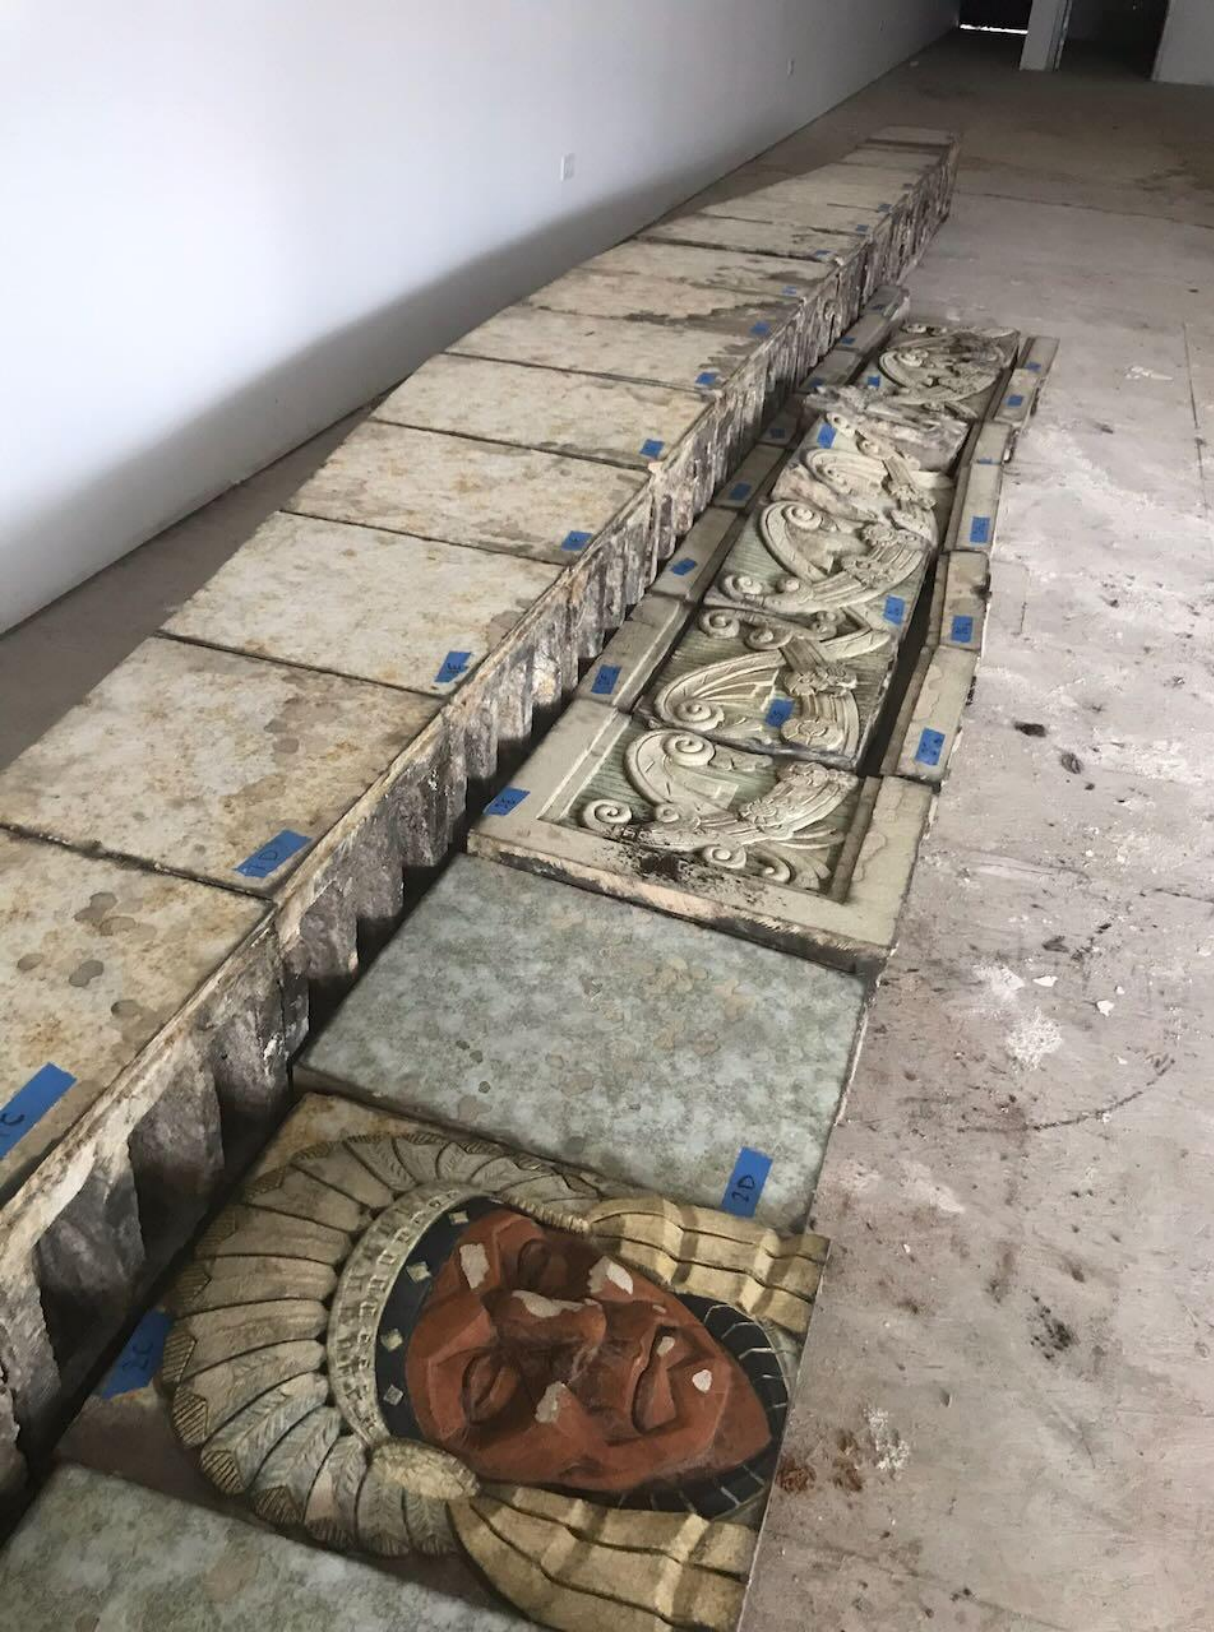
As each piece came off, they were kept onsite. The facade was reassembled, this time the floor, inside the building. This allowed the team to clearly see the pieces up close and inspect every side of them. Finally, a full picture of the facade's overall condition could be thoroughly visualized.

Based on the conditions of the pieces, it was determined that approximately 1/3 of the terra cotta was still in good condition. Another 1/3 needed minor repairs and the final 1/3 needed to be completely recreated. With that said, the facade was packed up and shipped to Brick's Inc. Little Village yard for the next steps.

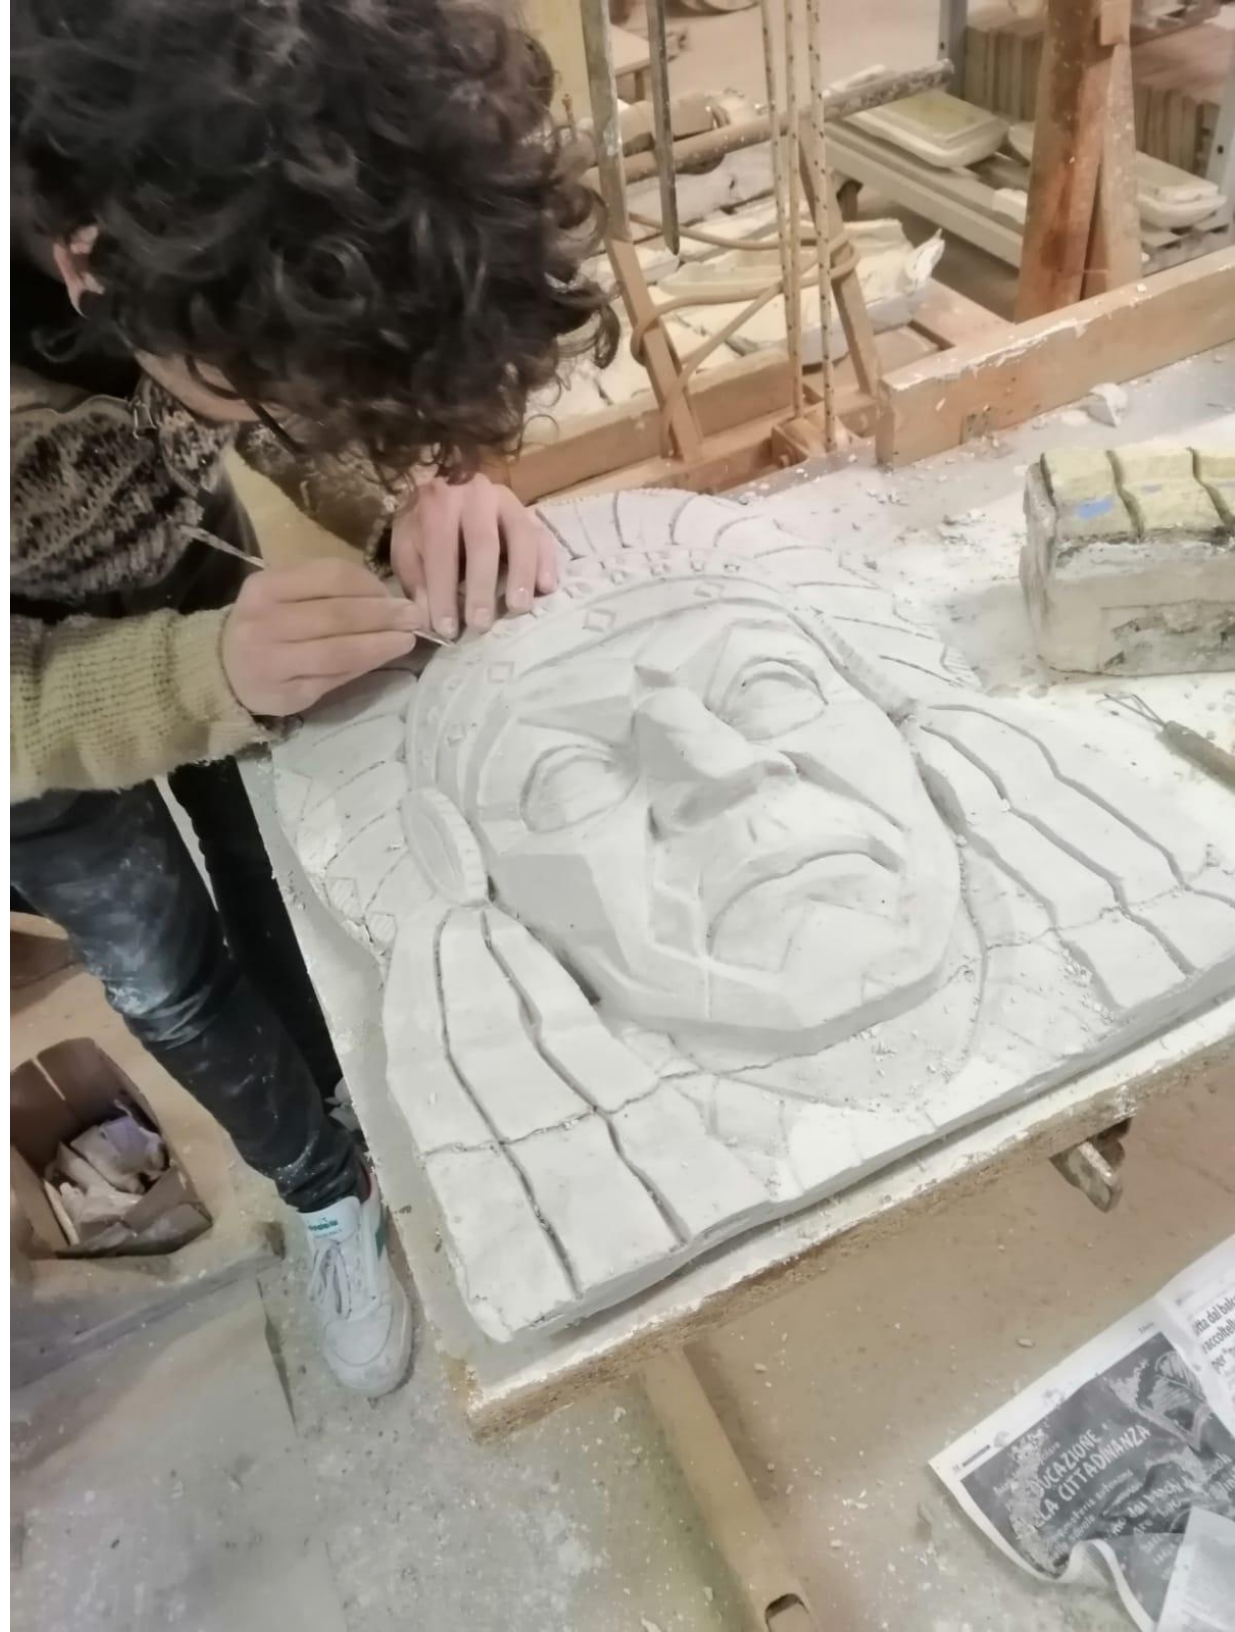
Some of the most challenging pieces to recreate for this project, were of course the angular faces with the very ornate headdresses. Not surprising, these are not the first terra cotta faces San Anselmo has had to create or even re-create in clay. In the past they have even been able to recreate terra cotta faces based solely on photographs. With the original heads in hand, this project was comparatively a walk in the park for these sculptors. They used the originals to make intensely detailed measurements of every feature and angle and eventually were able to make new molds.

The most difficult part of the entire process was not the sculpting, but the glazing of the terra cotta. The originals were not a single solid color but rather mottled mixtures. “There are multiple colors on many of those pieces,” says Dave Kafer of Bricks Inc., “with a base color and then top colors sprinkled and applied on top.”

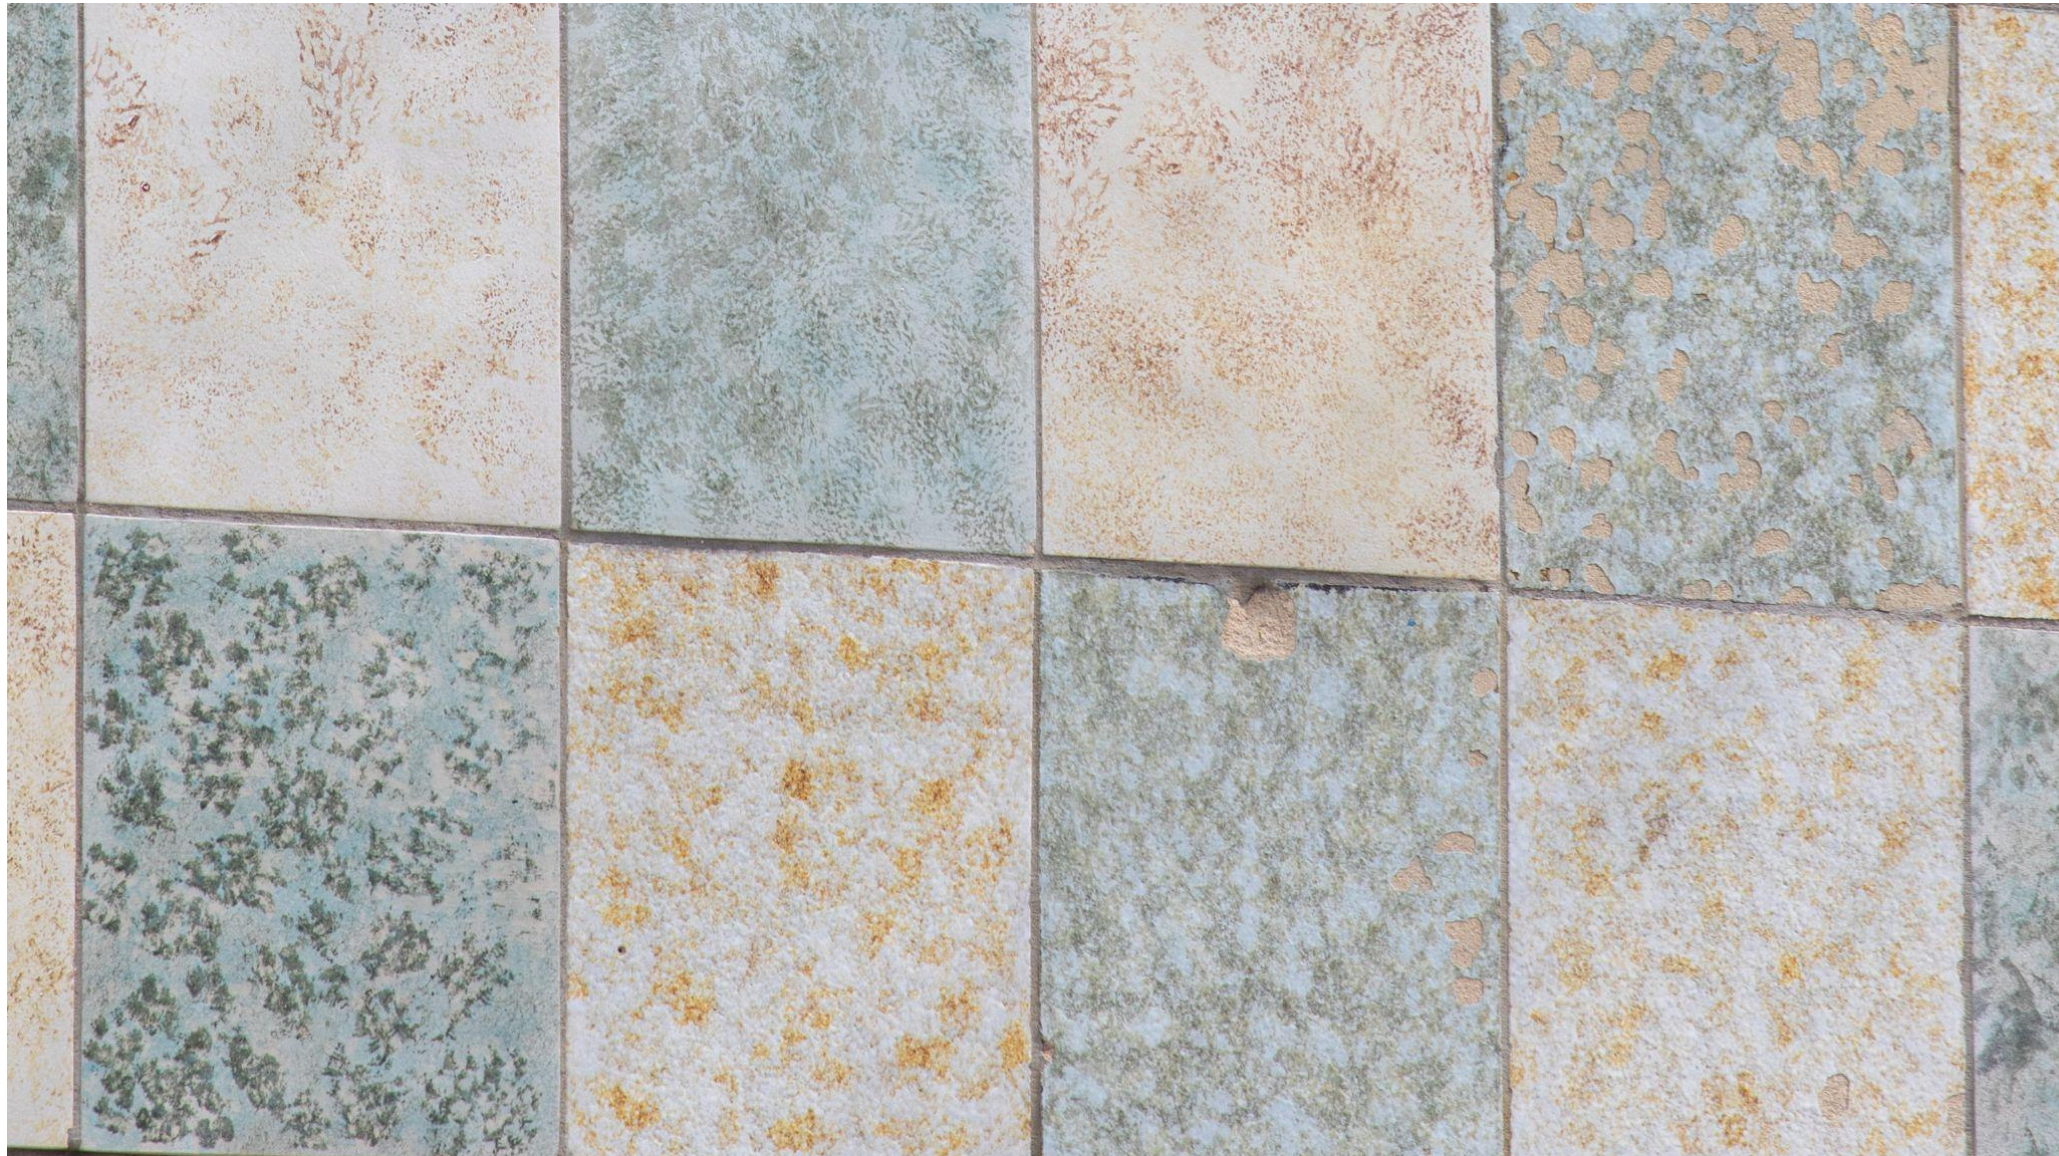
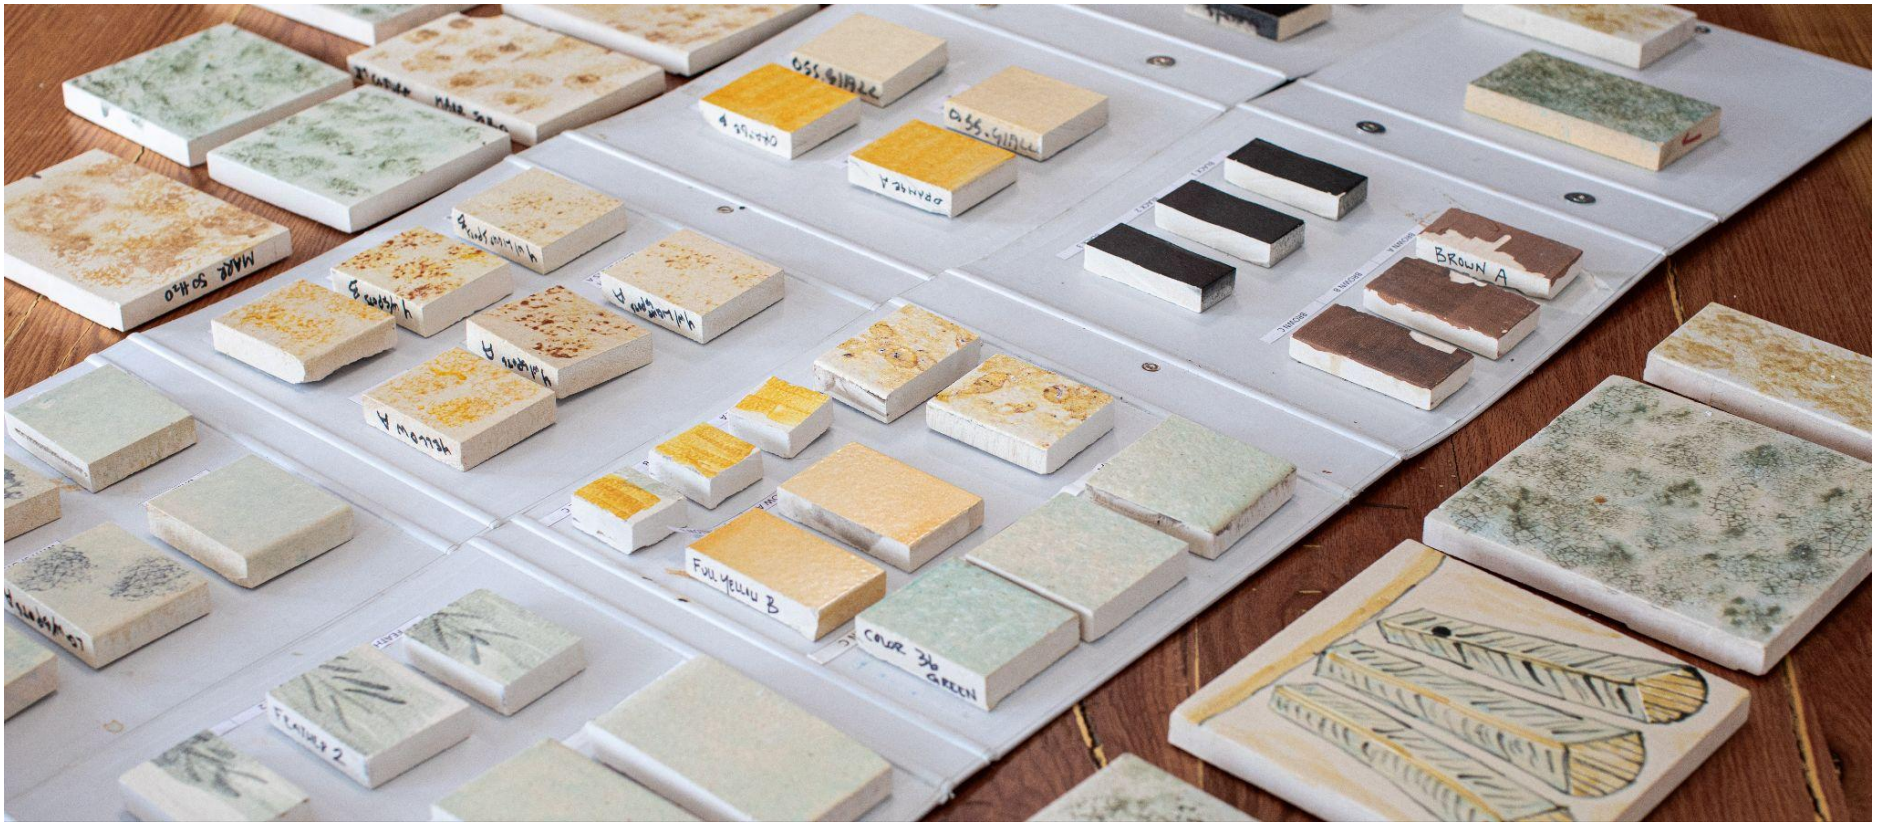
They tried applying the layers of glaze with brushes, with towels, with rollers, by spraying. “And you don’t really know what you’re going to get because the glaze is a totally different weapon when its fired,” says Kafer.

The successful technique? Soft sponges dabbed across the surface, but you would never know it. It looks just right, next to the originals. With final approval of the sculpted blocks and glazes, from all the stakeholders, the new terra cotta was now on its way to Chicago.

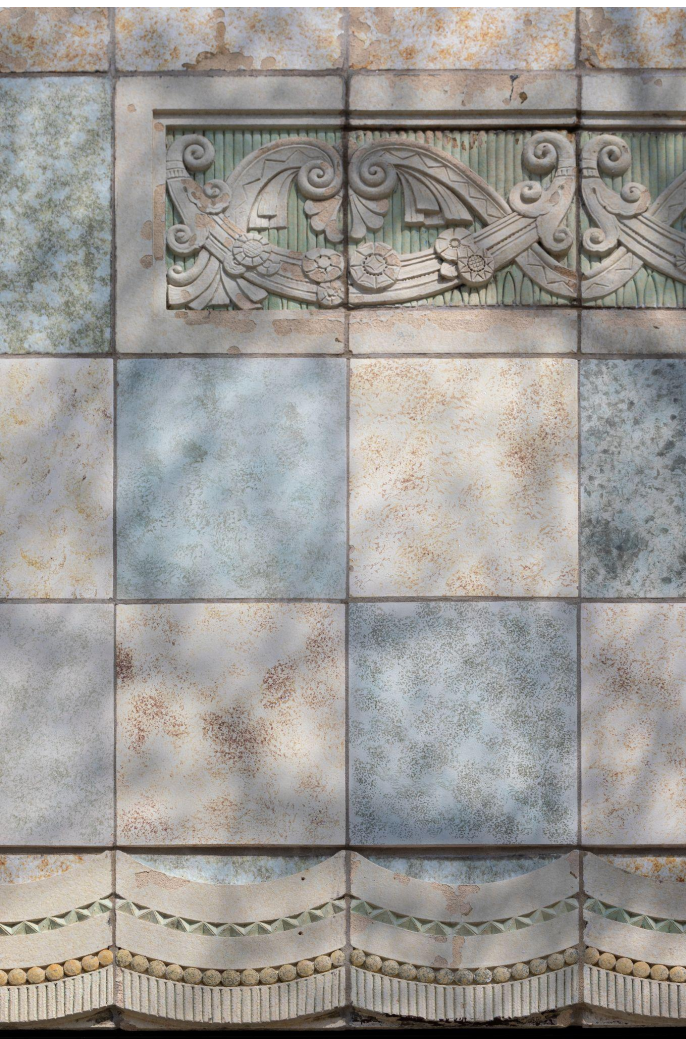
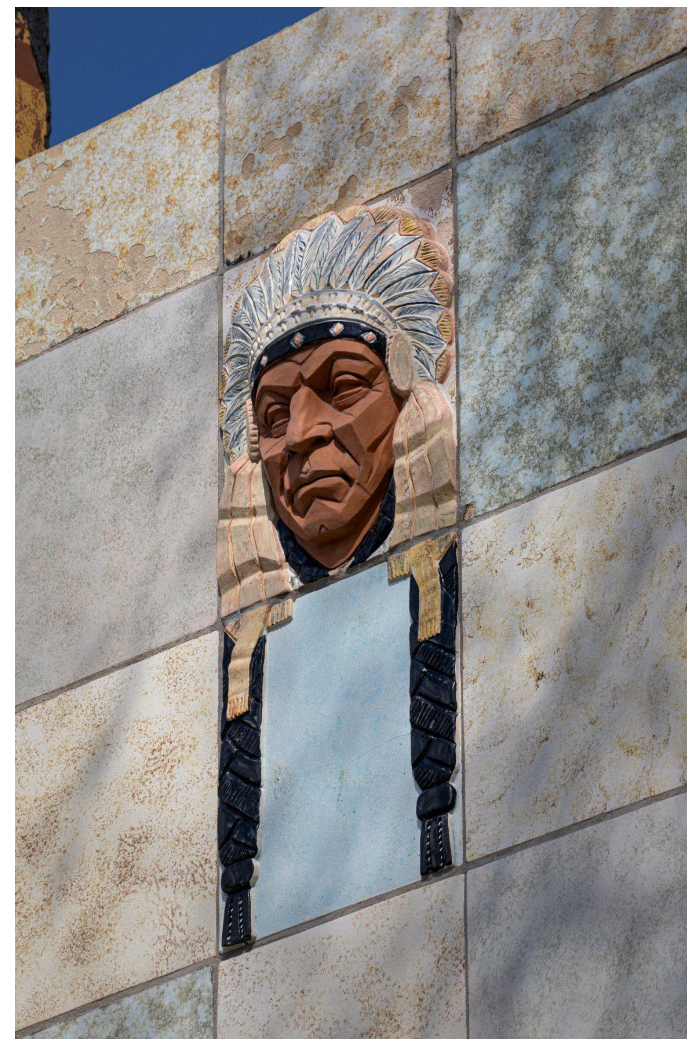
Upon arrival, the new terra cotta was blended with the old pieces that were previously salvaged. Szajna and Formed Space were now responsible for returning it to its rightful place in Uptown. At the time the facade was to be installed, the building was being occupied and it could not be brought inside the building for storage. Instead it was safely stored at Bricks Inc, in their warehouse in Little Village. Every day, Bricks Inc. delivered between 8 and 10 terra cotta pieces; this was as many as could be installed in a day.

At 4629 Broadway, Formed Space received and reassembled the terra cotta pieces. This time around, they worked from the bottom up. The facade was also treated and installed with new moisture barriers techniques and rust proof stainless steel ties in an attempt to preserve them as long as possible.
